## Research

# The Gap Rock Lighthouse: construction and typhoon damage

K. Y. Deng and S. W. Poon

This paper focuses on the Gap Rock lighthouse, a legendary maritime infrastructure built 130 years ago in the Chinese territory and an early example of joint venture among the Qing Dynasty, the British Empire and the Hong Kong Colonial Government over a course of two decades. Based on 4 years of cross-territorial archival and field research as well as in-depth interviews with descendants of two key stakeholders, the origin of this lasting legacy on the sea is traced, followed by a detailed account of its challenging processes of planning, design and construction, and of the considerable damage to the compound by a severe typhoon in 1893. A qualitative analysis of the key contributing factors of the damage was conducted by taking into consideration the Island's unique topography and the historical records of territorial weather reports. A re-construction of the typhoon impact on the Lighthouse is presented to explain the possible mistakes in its siting and design that eventually caused the severe damage. This serves as a reminder of the significance of a thorough geographical investig

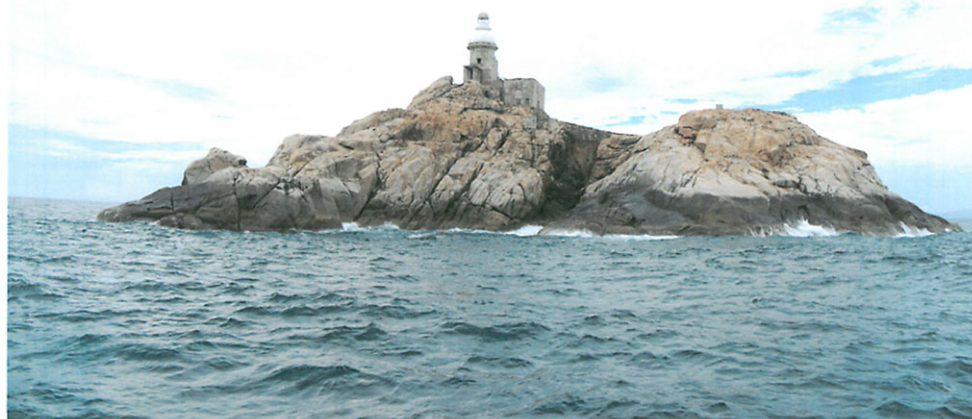
**Figure 3.** Gap Rock and the lighthouse (note the gap between the two portions of the Island). *Source:* Photo taken by the research team in 2014. (Online version in colour.)

Gap Rock is a tiny island of about 12 000 m<sup>2</sup> at the southwestern extremity of Dangan (Lema) Islands and Jiapeng (Kypong) Islands, 50 km from the southwest of Hong Kong (figure 1). The barren rocky island was named so because of the existence of a gap between its two portions (figures 3 and 4).

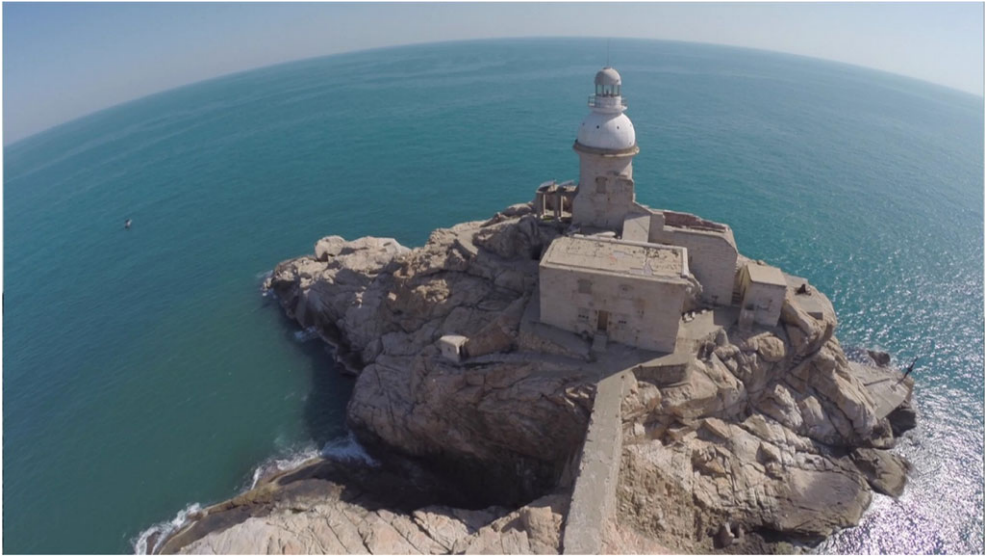
**Figure 4.** Aerial photo of the Gap Rock lighthouse showing the gap and the causeway. *Source:* Photo taken by the research team in 2016. (Online version in colour.)

The gap on the western face between the two sections is less exposed than that on the eastern side and is of a much more favourable shape. The landing place has been rightly fixed on this sheltered western face. (figures 3 and 4)

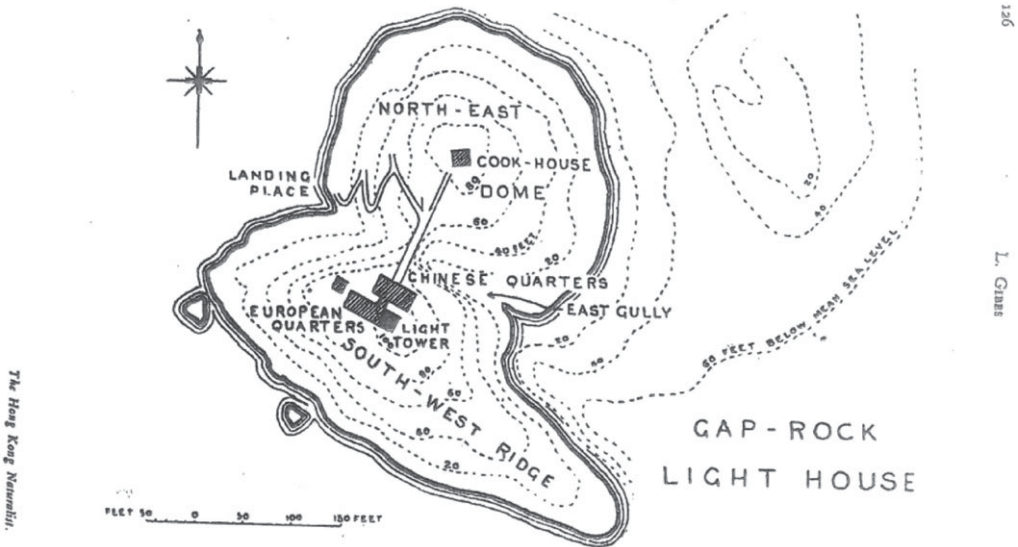
**Figure 5.** The contours surveyed by Gibbs [22]. *Source:* L.G. Gibbs' paper 'The Gap Rock—some early history'.

height of 11 m, whilst the adjacent face of the gap rises 23 m, in a horizontal width of 15 m. The configuration of the eastern gap and spur of the Island that any sea waves from North-east to South-east would concentrate into a funnel shaped cavity, thereby intensifying the abnormally severe waves which are associated with the occurrence of typhoons.

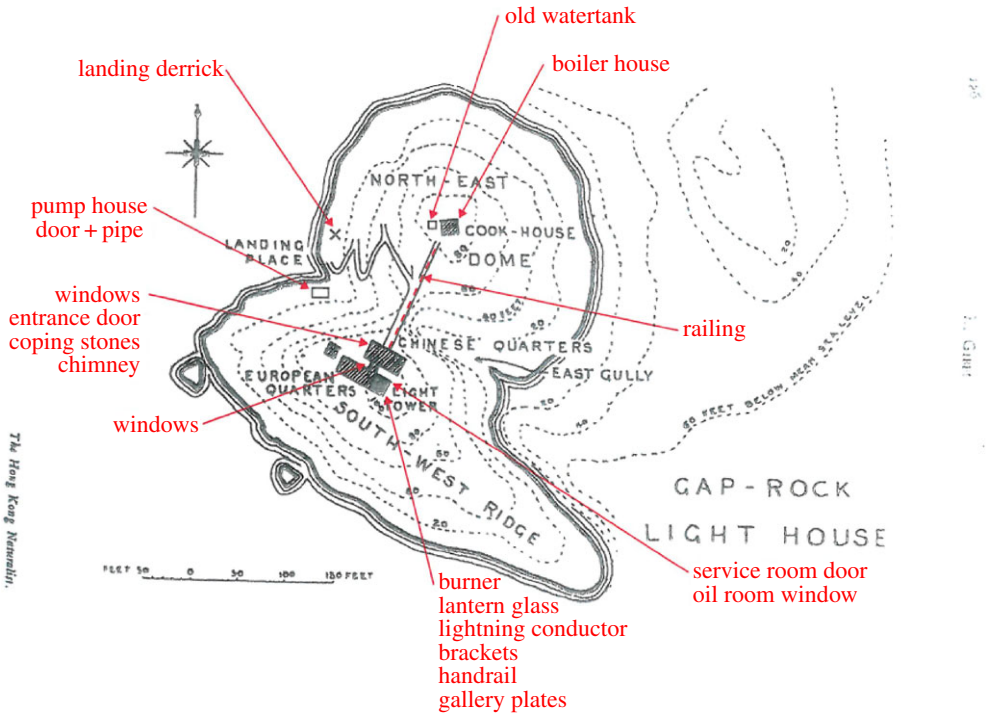
**Figure 12.** Typhoon damage to the lighthouse compound in October 1893. *Source:* Caption added to the contour map drawn by Gibbs [22]. (Online version in colour.)

The damage, listed in table 1 and indicated in figure 12, was recorded by the Director of Hong Kong Public Works Department [43] during the visit to the island with the Harbour Master on 11 October 1893.

estimated elevation above mean sea level (m)	location	description of the damage
4 m	West side of the Island	the landing derrick was carried away
4 m	West side of the Island	a short length of the land wire was displaced
4 m	pump house	the door and a 9 m long pipe were carried away
25 m	causeway	the railing on the eastern side was bent level with the ground
25 m	North of the Island	the old water tank was carried away
23 m	North of the Island	the boiler room and the door were broken
26 m	ground floor of lower building	the window of the telegraph office facing East, the entrance door facing North and the typhoon bar of the entrance door were broken
29 m	upper floor of lower building	the window in the bathroom and the Chinese quarters facing North and East were broken
32 m	roof of lower building	five coping stones and the chimney masonry work were damaged
26 m	upper building	salt water splashing onto the roof drained through the downpipe to the water tank at the basement.

30 m	stairway gangway	two small windows were broken
32 m	oil room	the eastern window was knocked in
35 m	service room	one panel indoor was broken and the room was flooding due to the water entering through the broken lantern glazing
39 m	lantern room	six brackets, three gallery plates and a portion of handrail in the gallery around the lantern were broken; one upper panel of the prism was broken and three bottom panels were slightly damaged; the burner was bent
43 m	lantern	three panes of 12 mm thick on the eastern side of the lantern were broken

The severe damage to the lantern glazing was due to the strong seas, being forced into the gully at the east, directed up by the funnel action and deflected vertically by the side wall of the causeway. The mass of water, elevated by the wave, was blasted onto the lantern by the gale. The lantern glazing was a flat plate and proved unable to resist the impact force from the mass of the water. The consultants later found that the lighthouse was erected in the wrong part of the island, and the design was based on a site visit in the fine weather and the consideration of favourable conditions.
