## Research

# The Gap Rock Lighthouse: construction and typhoon damage

K. Y. Deng and S. W. Poon

This paper focuses on the Gap Rock lighthouse, a legendary maritime infrastructure built 130 years ago in the Chinese territory and an early example of joint venture among the Qing Dynasty, the British Empire and the Hong Kong Colonial Government over a course of two decades. Based on 4 years of cross-territorial archival and field research as well as in-depth interviews with descendants of two key stakeholders, the origin of this lasting legacy on the sea is traced, followed by a detailed account of its challenging processes of planning, design and construction, and of the considerable damage to the compound by a severe typhoon in 1893. A qualitative analysis of the key contributing factors of the damage was conducted by taking into consideration the Island's unique topography and the historical records of territorial weather reports. A re-construction of the typhoon impact on the Lighthouse is presented to explain the possible mistakes in its siting and design that eventually caused the severe damage. This serves as a reminder of the significance of a thorough geographical investig

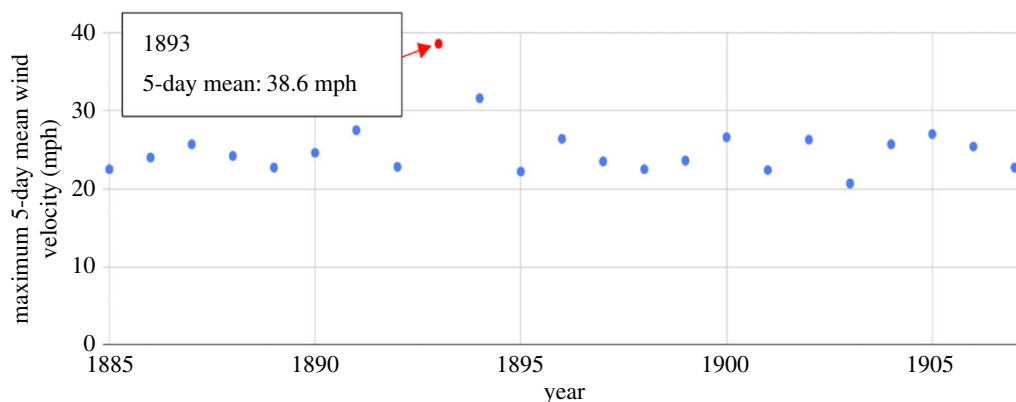
Though no direct measurement of wind intensity was taken on the island, the 5-day means of wind intensity observed in Hong Kong gives an impression of how strong the typhoon was when it clashed with the Island [42]. The maximum 5-day means of wind velocity each year observed in Hong Kong during the period of 28 September–2 October in year 1893 was 38.6 mph (Year 1893 Report of the Director of Hong Kong Observatory) and is the highest between 1885 and 1907, as shown in figure 10.

**Figure 10.** The maximum 5-day mean wind velocities 1885–1907. *Source:* Hong Kong Observatory Annual Report 1885–1907 [42]. (Online version in colour.)

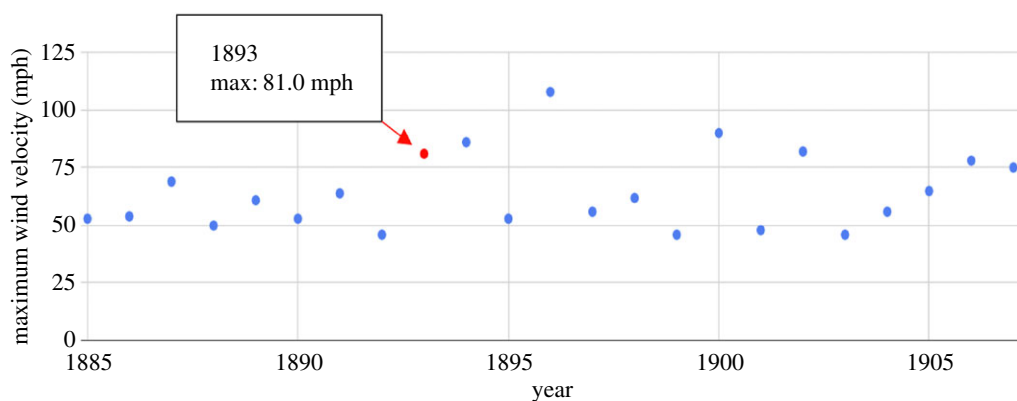
The maximum wind speed recorded on 2 October 1893 at the observatory was 81 mph which was confirmed lately by their staff. This does not give the exact magnitude of wind blowing at Gap Rock, 50 km away, yet its severity can be seen from figure 11 which shows the distribution of maximum wind speed from 1885 until 1907 [42].

As shown from figure 11, the wind speed recorded in 1893 is not the greatest but among the highest ones. The wind velocity recorded for the typhoon in October 1894 was even greater than the one in 1893, yet the damage was not comparable to the one 12 months previously. The wind

**Figure 11.** Maximum wind speed recorded at the Hong Kong Observatory or Gap Rock. *Source:* Hong Kong Observatory Annual Report (1885–1907) [42]. (Online version in colour.)

recorded in 1894 was blowing between northeast and southwest, within which the lighthouse compound was better shielded by the southwest ridge.
